**Flood Control Project Maintenance
Levee Inspections**

Fall 2013 Levee Maintenance Deficiency Summary Report

Reclamation District No. 0817 Carlin

Levee Inspection Report By Mile - Fall 2013

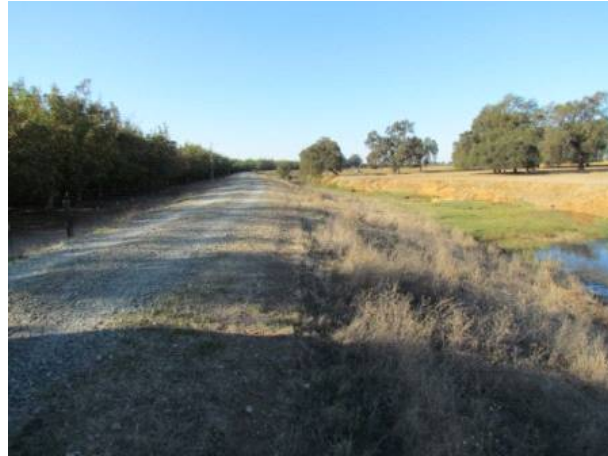
Levee Mile Report Line	4
Start Levee Mile	0.00
End Levee Mile	3.75
Location	Water Side
Category	Earthen Levee
Item	Vegetation

This photo was taken from the crown of the levee facing west looking at the vegetation on the waterward side of the levee.

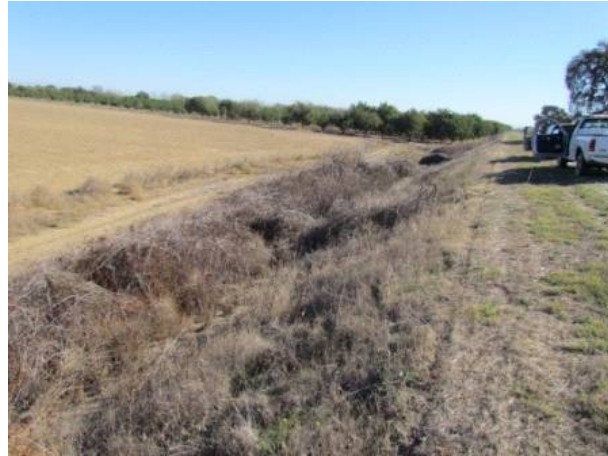
Levee Mile Report Line	3
Start Levee Mile	0.27
End Levee Mile	0.27
Location	Land Side
Category	Earthen Levee
Item	Vegetation

This photo was taken from the crown of the levee facing east looking at the blackberry bushes on the landward slope of the levee. They have been sprayed but still need to be removed.

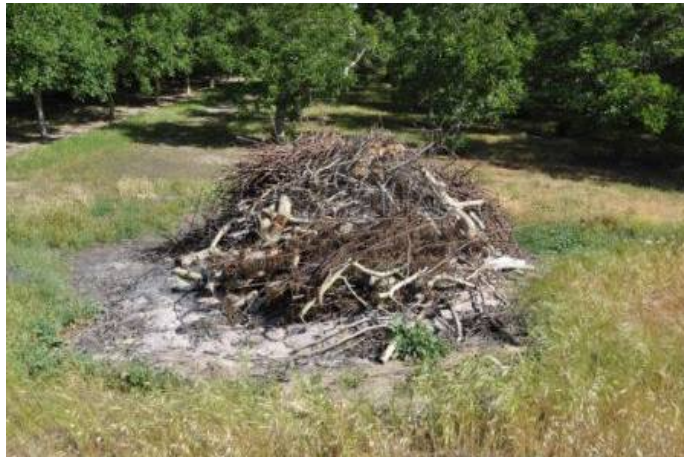
Levee Mile Report Line	4
Start Levee Mile	1.54
End Levee Mile	1.54
Location	Land Side
Category	Earthen Levee
Item	Encroachments

Pruning pile at L/S levee toe.

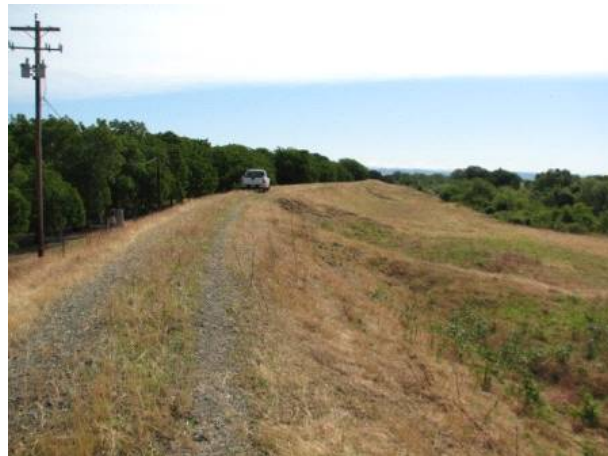
Levee Mile Report Line	7
Start Levee Mile	2.08
End Levee Mile	3.19
Location	Land Side
Category	Earthen Levee
Item	Slope Stability

Levee mile 2.08, this photo shows the slope is less than required, this is the downstream limit of the site, this is the waterside slope.

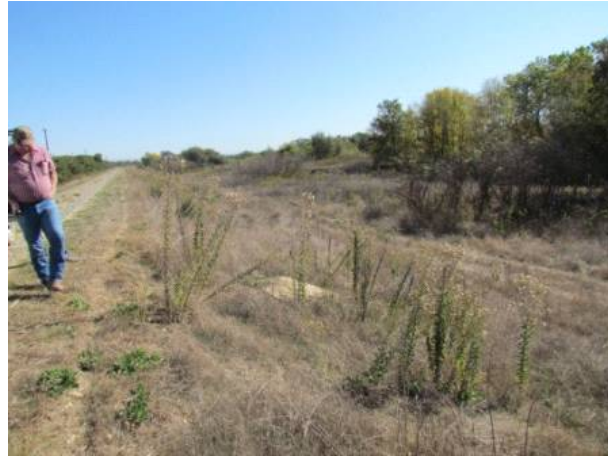
Levee Mile Report Line	10
Start Levee Mile	2.17
End Levee Mile	2.17
Location	Water Side
Category	Earthen Levee
Item	Animal Control

This photo was taken from the crown of the levee facing east looking at a medium sized animal burrow in the the waterward side of the levee slope.

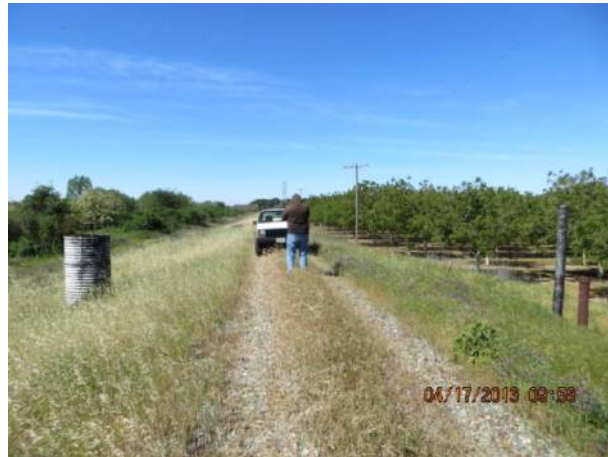
Levee Mile Report Line	11
Start Levee Mile	2.40
End Levee Mile	2.40
Location	Water Side
Category	Supplemental
Item	DWR UCIP Field Study

Levee Crown: CMP riser with slide gate on WS and slender CMP riser with siphon breaker on LS.

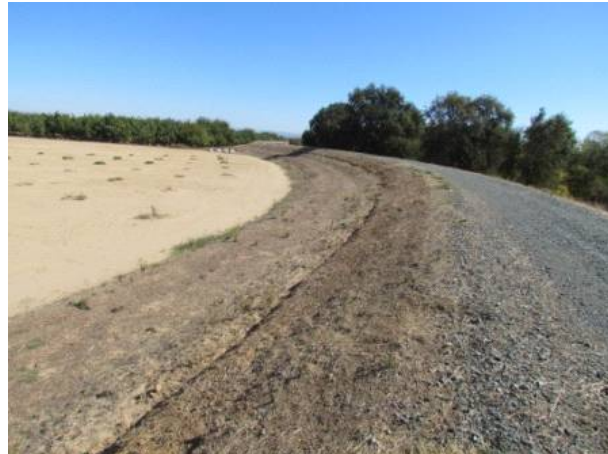
Levee Mile Report Line	12
Start Levee Mile	3.74
End Levee Mile	3.74
Location	Land Side
Category	Earthen Levee
Item	Slope Stability

LMR No.	Levee Mile		Category	Item	Location *	Rating ** +	Action/Comment	GPS Latitude/Longitude		Issue No. Photo
	Start	End						Start	End	
12	3.74	3.74	Earthen Levee	Slope Stability	LS	A/W	S1 : Repair slope instability. Inspector Comments: Separation line in the soil on the landward side between the clay and the sand.	38.992656 ° -121.439508 °	38.992656 ° -121.439508 °	6 Y

This photo was taken from the crown of the levee facing east looking at the separation line in the soil on the land ward side between the clay and the sand.
